Whittemore- Robbins Carriage House Restoration

Project Completion Report

Town of Arlington

Ward A. Hamilton
MSc, Historic Preservation

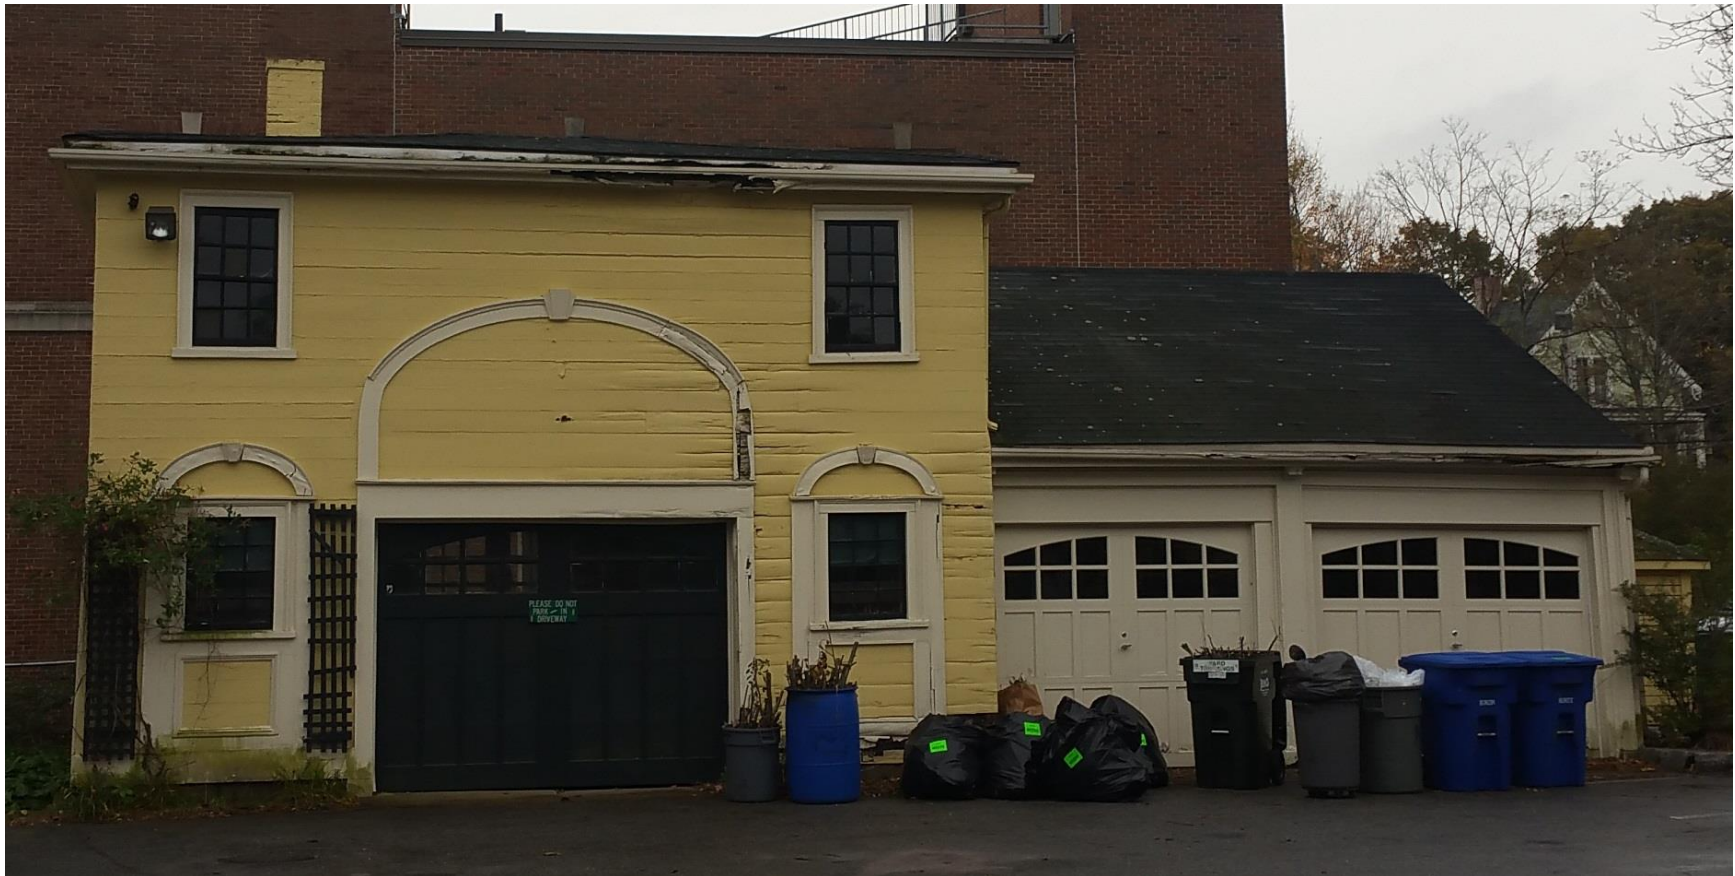
The main block of the building is consistent with the Adamesque, federal style popular in this region from 1780 to 1820. Such buildings are typically two-story, rectangular in construction, with side gable or low-hipped roofs. The flushboard siding (seen here on the front façade) was meant to imitate stone and is considered a high-style elaboration. A semi-circular or elliptical fanlight over the front entryway is also a character defining feature of the style and found on the Whittemore Robbins House. Here, the motif was incorporated over the barn doors as well as part of the fenestration. Windows arranged symmetrically, typically double-hung, six over six sash separated by thin wooden muntin bars are also character defining features. *Source: Ward A. Hamilton*

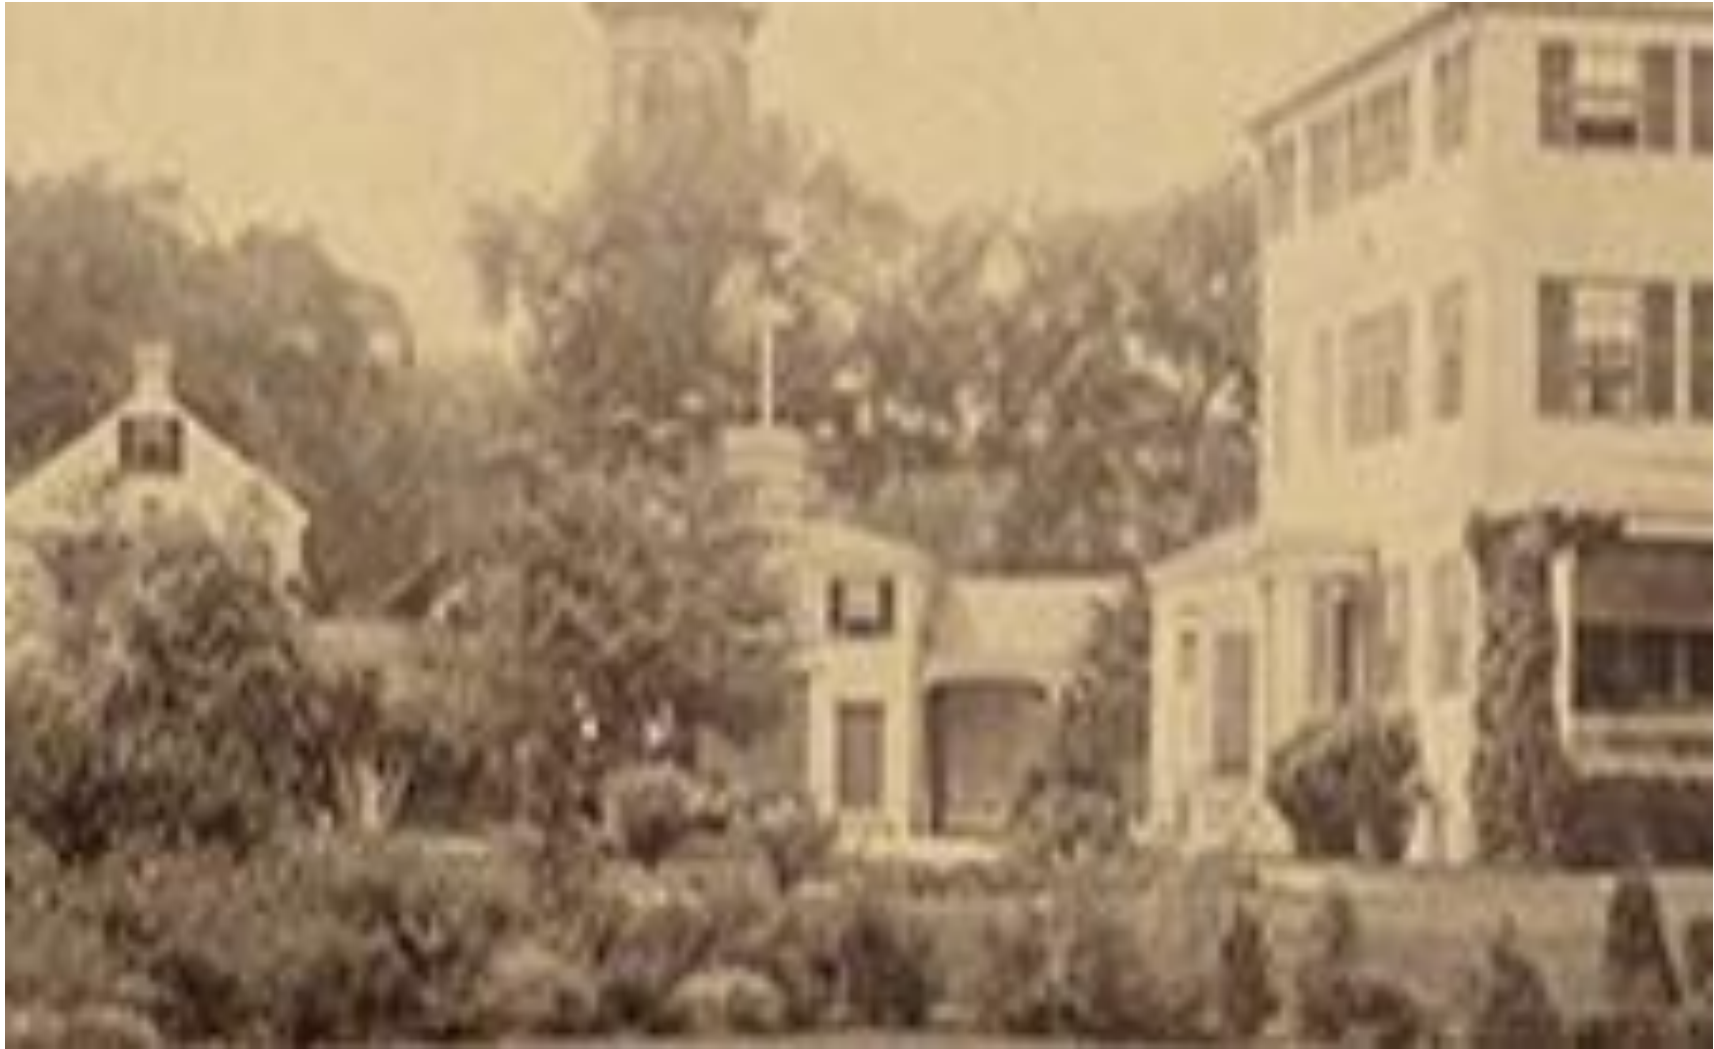
The Whittemore Robbins House, carriage house in background, circa 1890, with extant rooftop dovecote. A single door to the right of the double doors had since been converted to a window. The double doors shown here were significantly taller than the existing garage door.
Source: <http://www.yourarlington.com/search/news-archive/32-development/8506-cpa-030416.html>

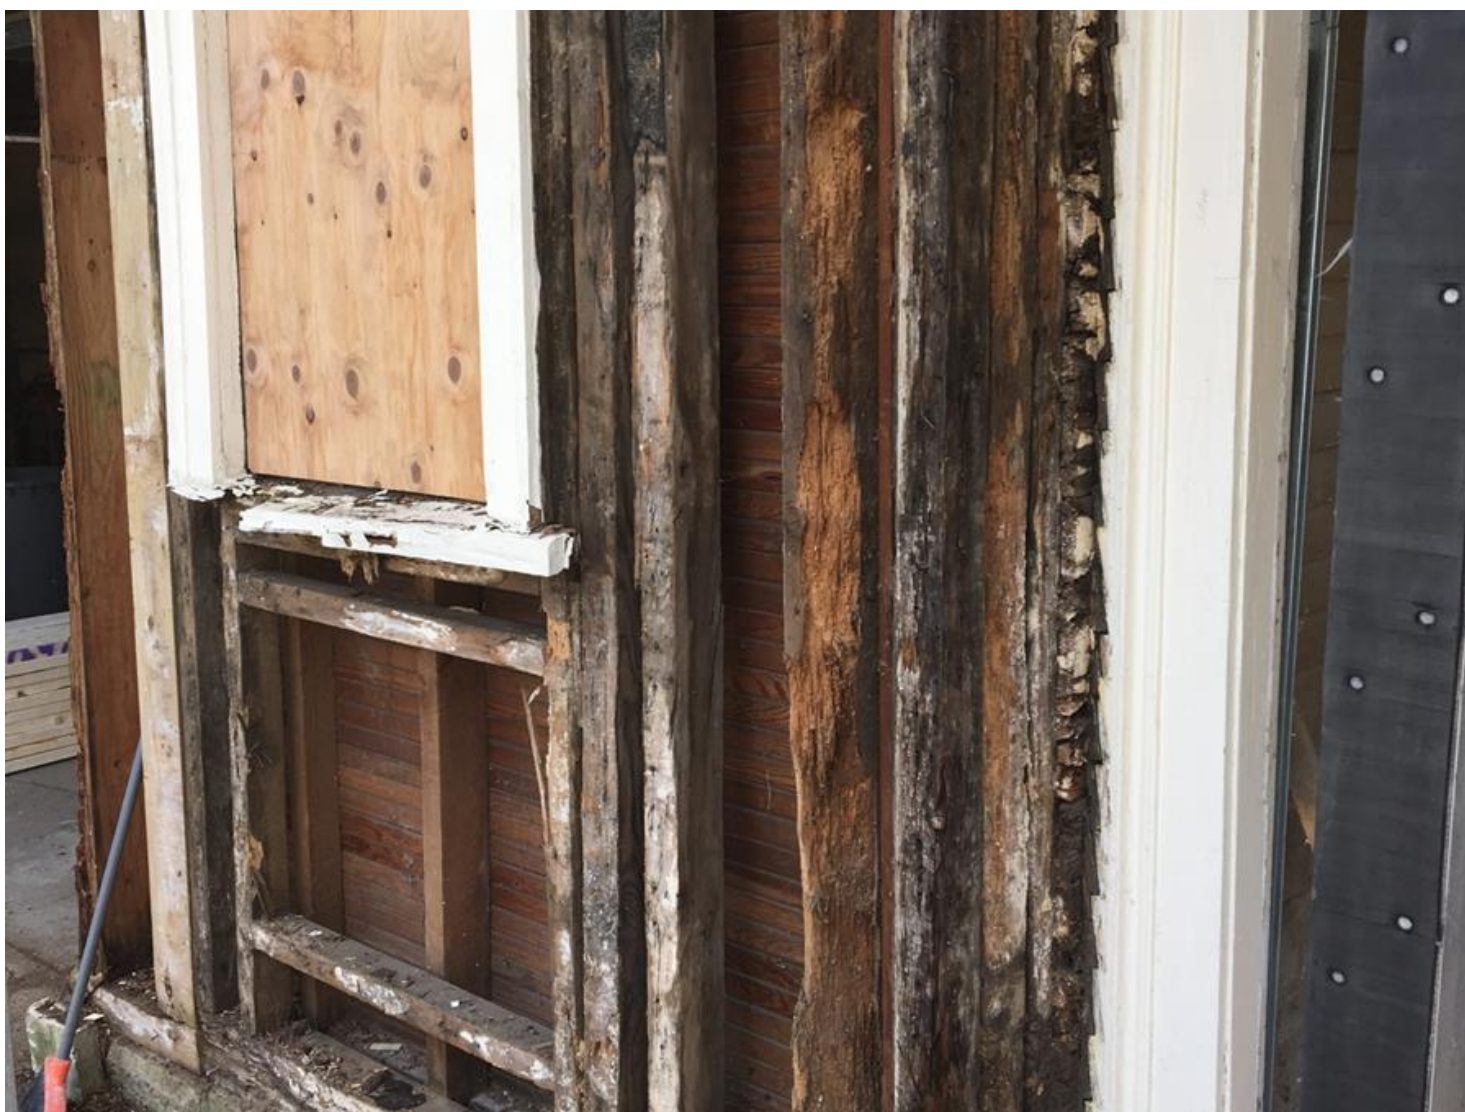
Main structure, front corner. Deteriorated framing members. *Source: Jim Feeney*

New steel plates and wood framing members were joined to the existing, original frame. Around the entire perimeter of the main house block of the building all rafter tails and outriggers were rebuilt. New framing members were sistered to existing framework to support the load of the gutter system and to provide sound nailing surfaces for new trim, fascia and soffit plates. Given the extensive insect damage and rot uncovered, new wood was treated with bora-care with a mold-care additive with anti-fungicidal properties. Existing non-treated ledger boards were replaced with kiln-dried, pressure treated lumber at the main floor concrete slab and modern anchors and epoxy products were used where pinning to foundation walls was necessary.

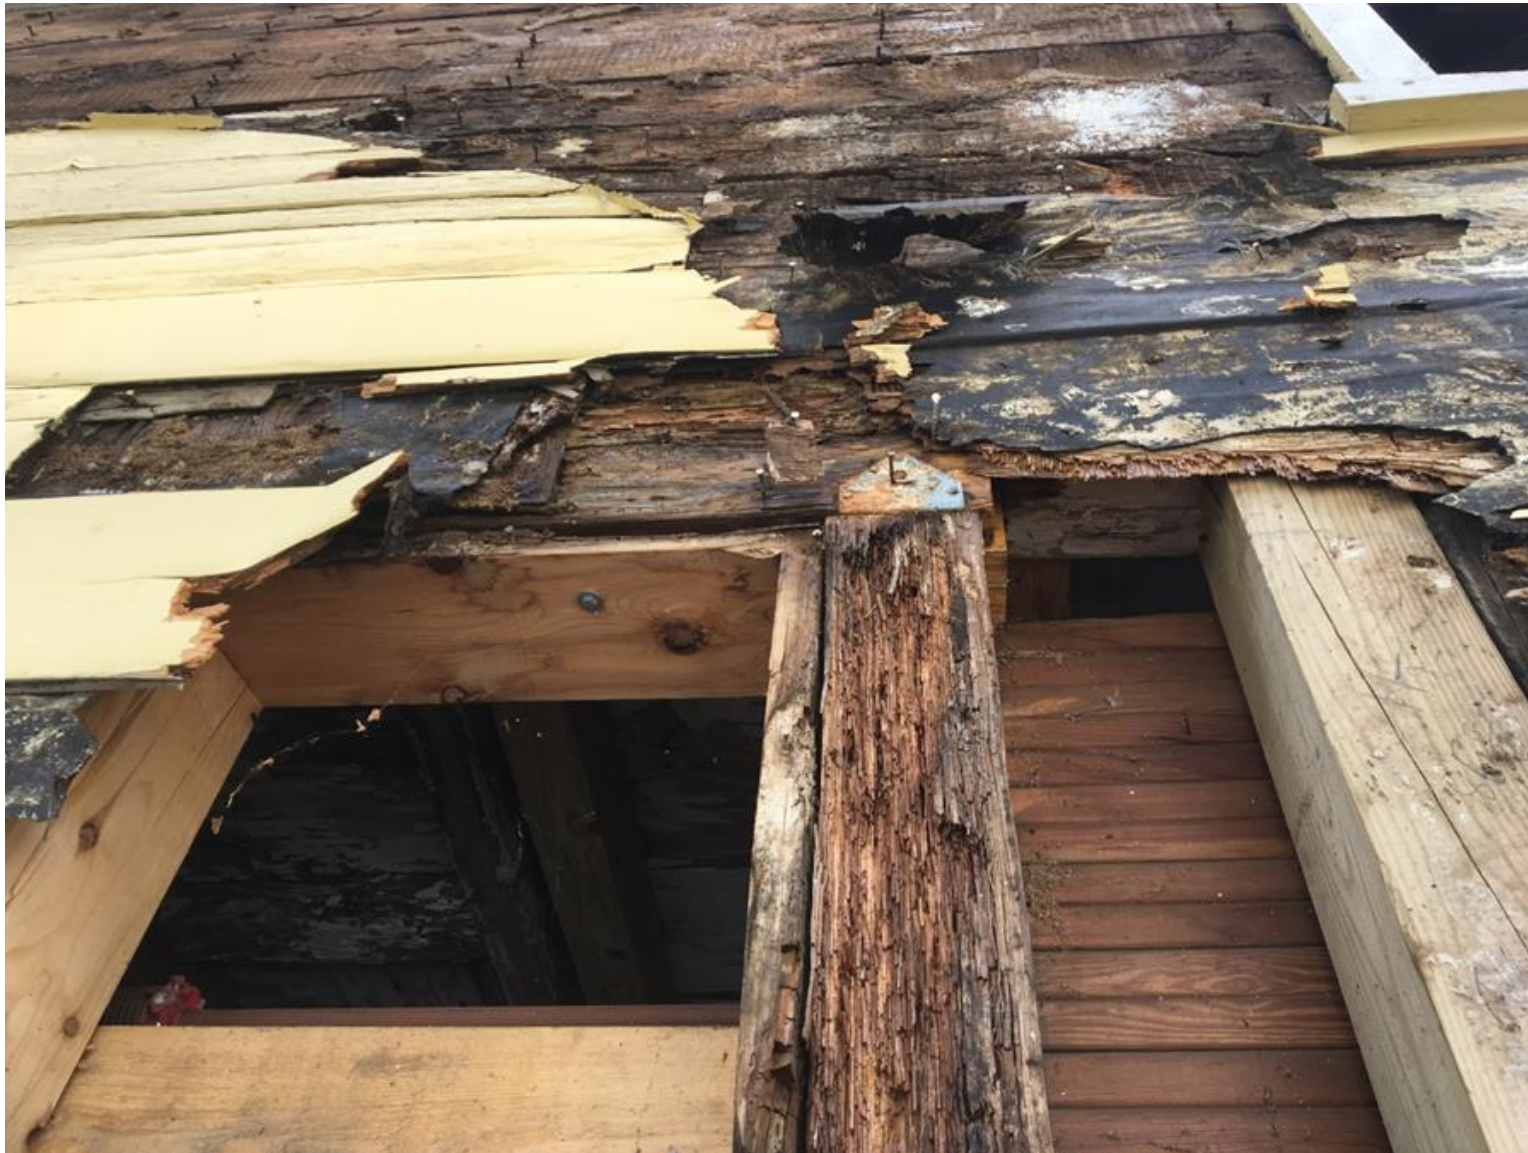
Main structure, front right corner. Deteriorated LVL Beam and 2x shoring installed 2001. *Source: Jim Feeney*

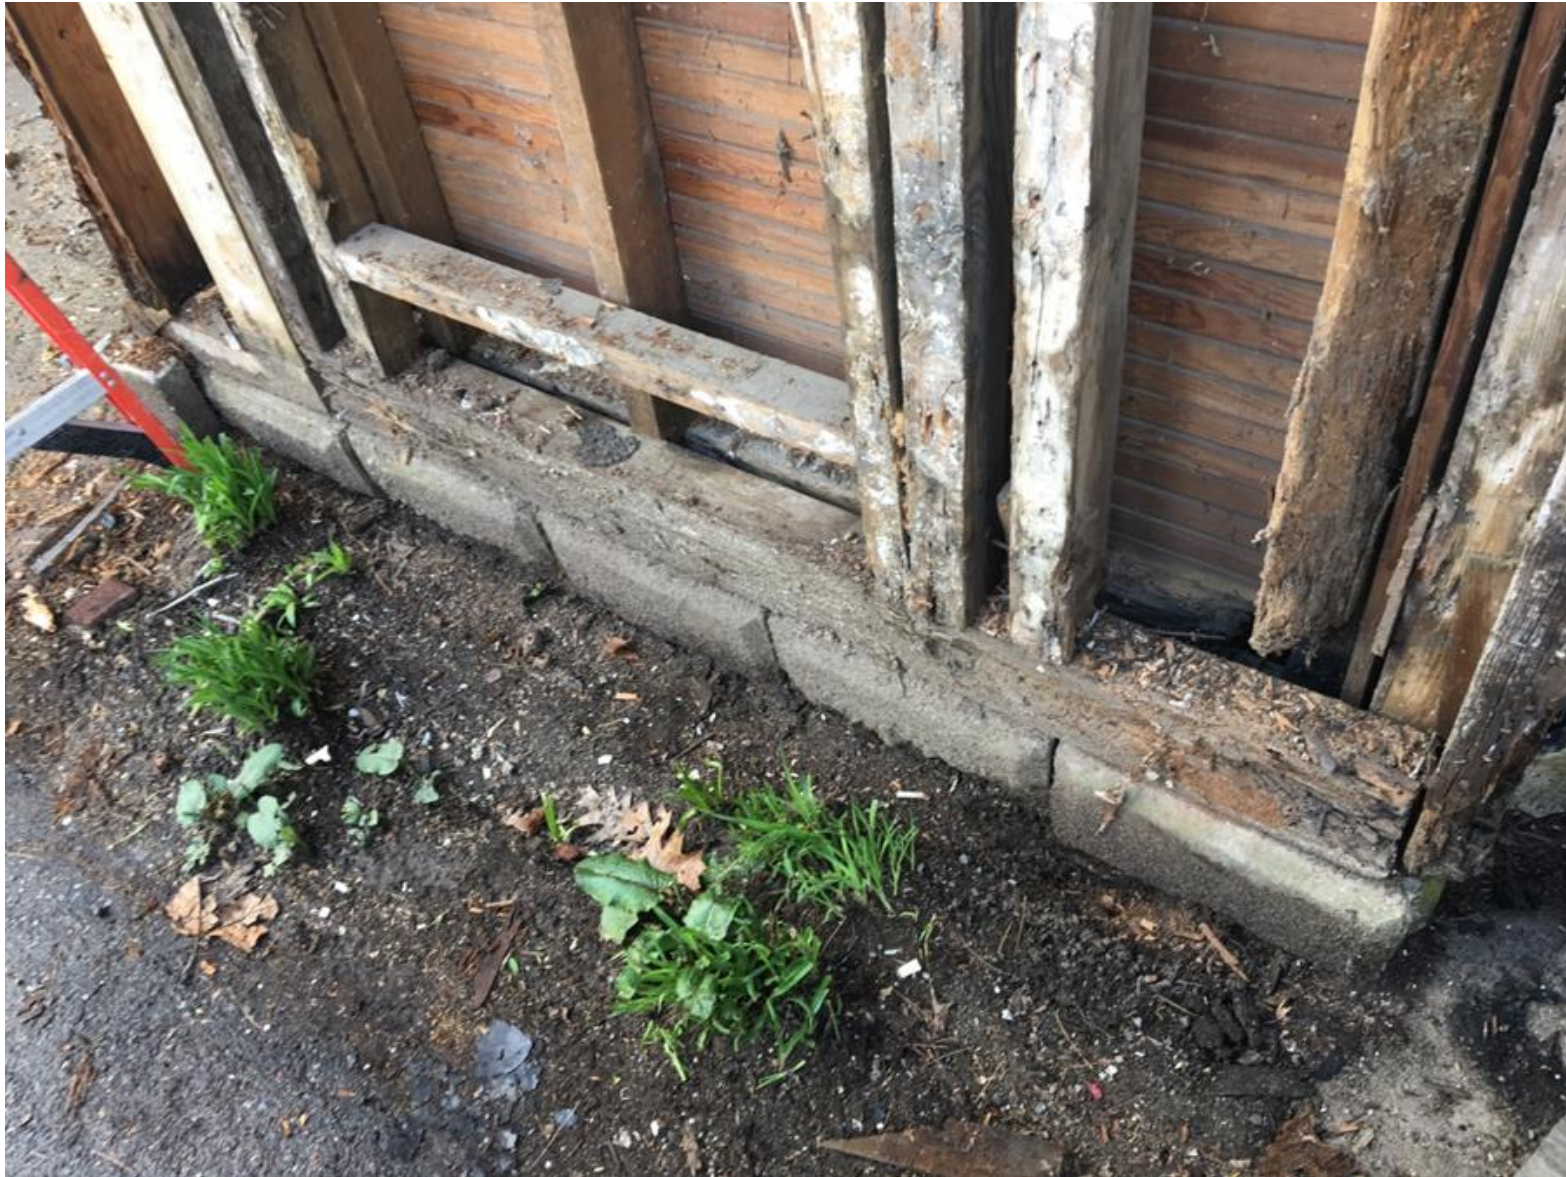
Main structure, front right corner. Offset CMUs, disjointed and differentially settled sill plate. *Source: Jim Feeney*

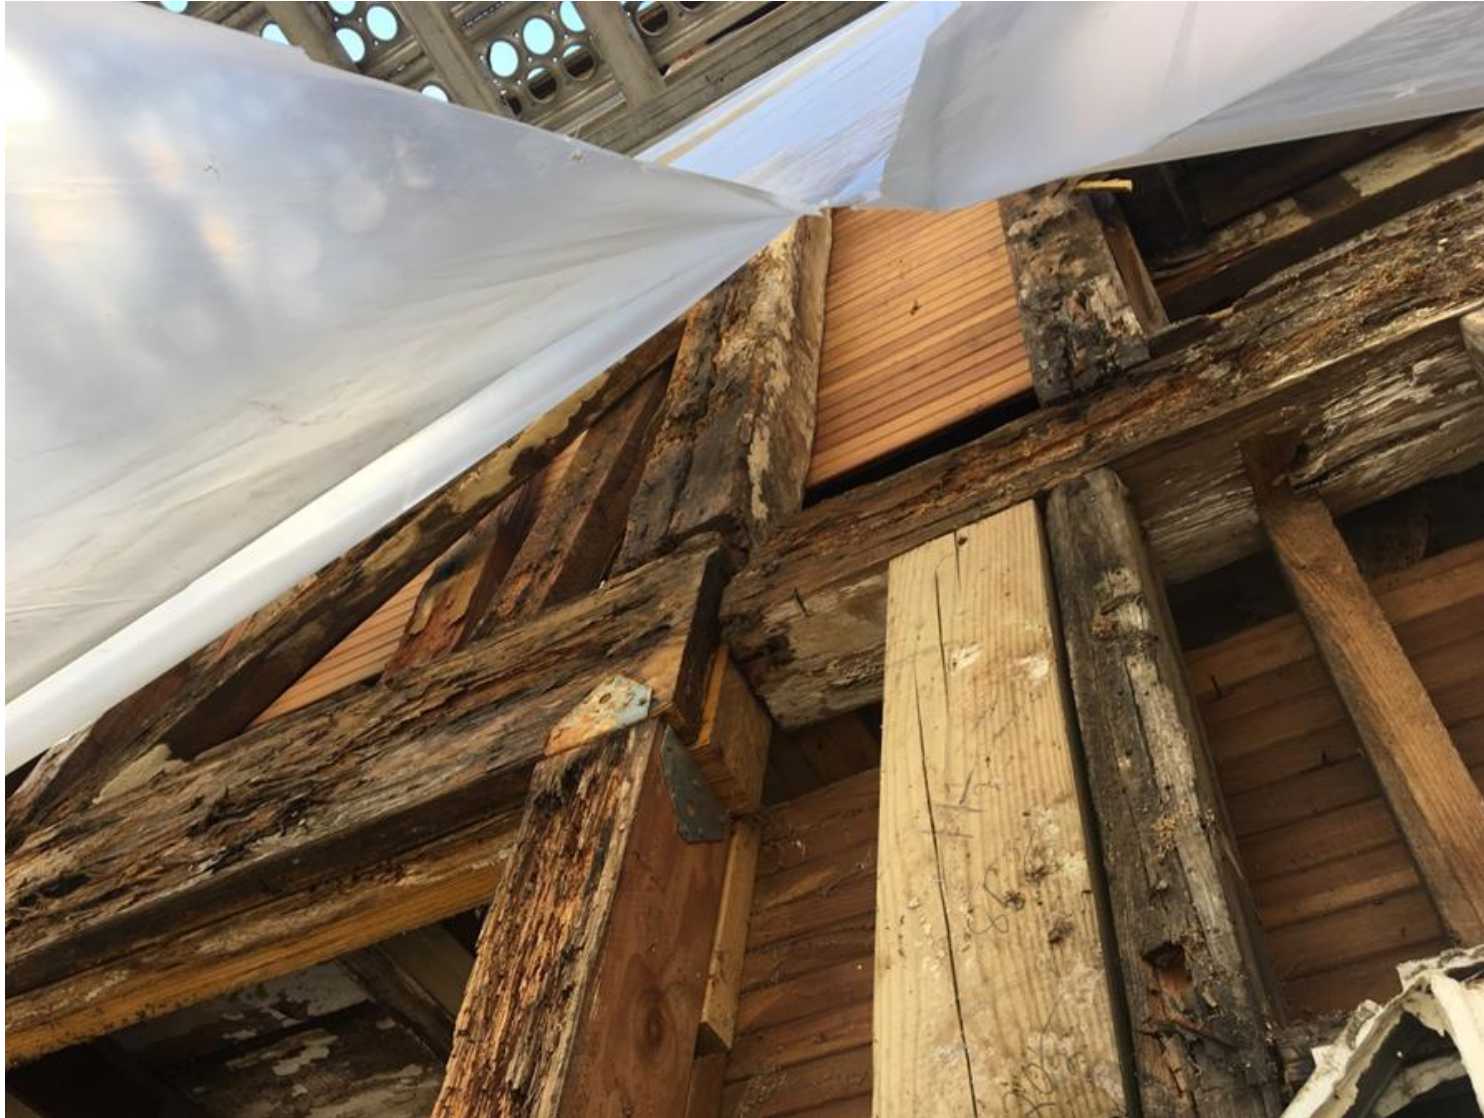
Main structure, front right corner. Deteriorated framing, original and circa 2001. *Source: Jim Feeney*

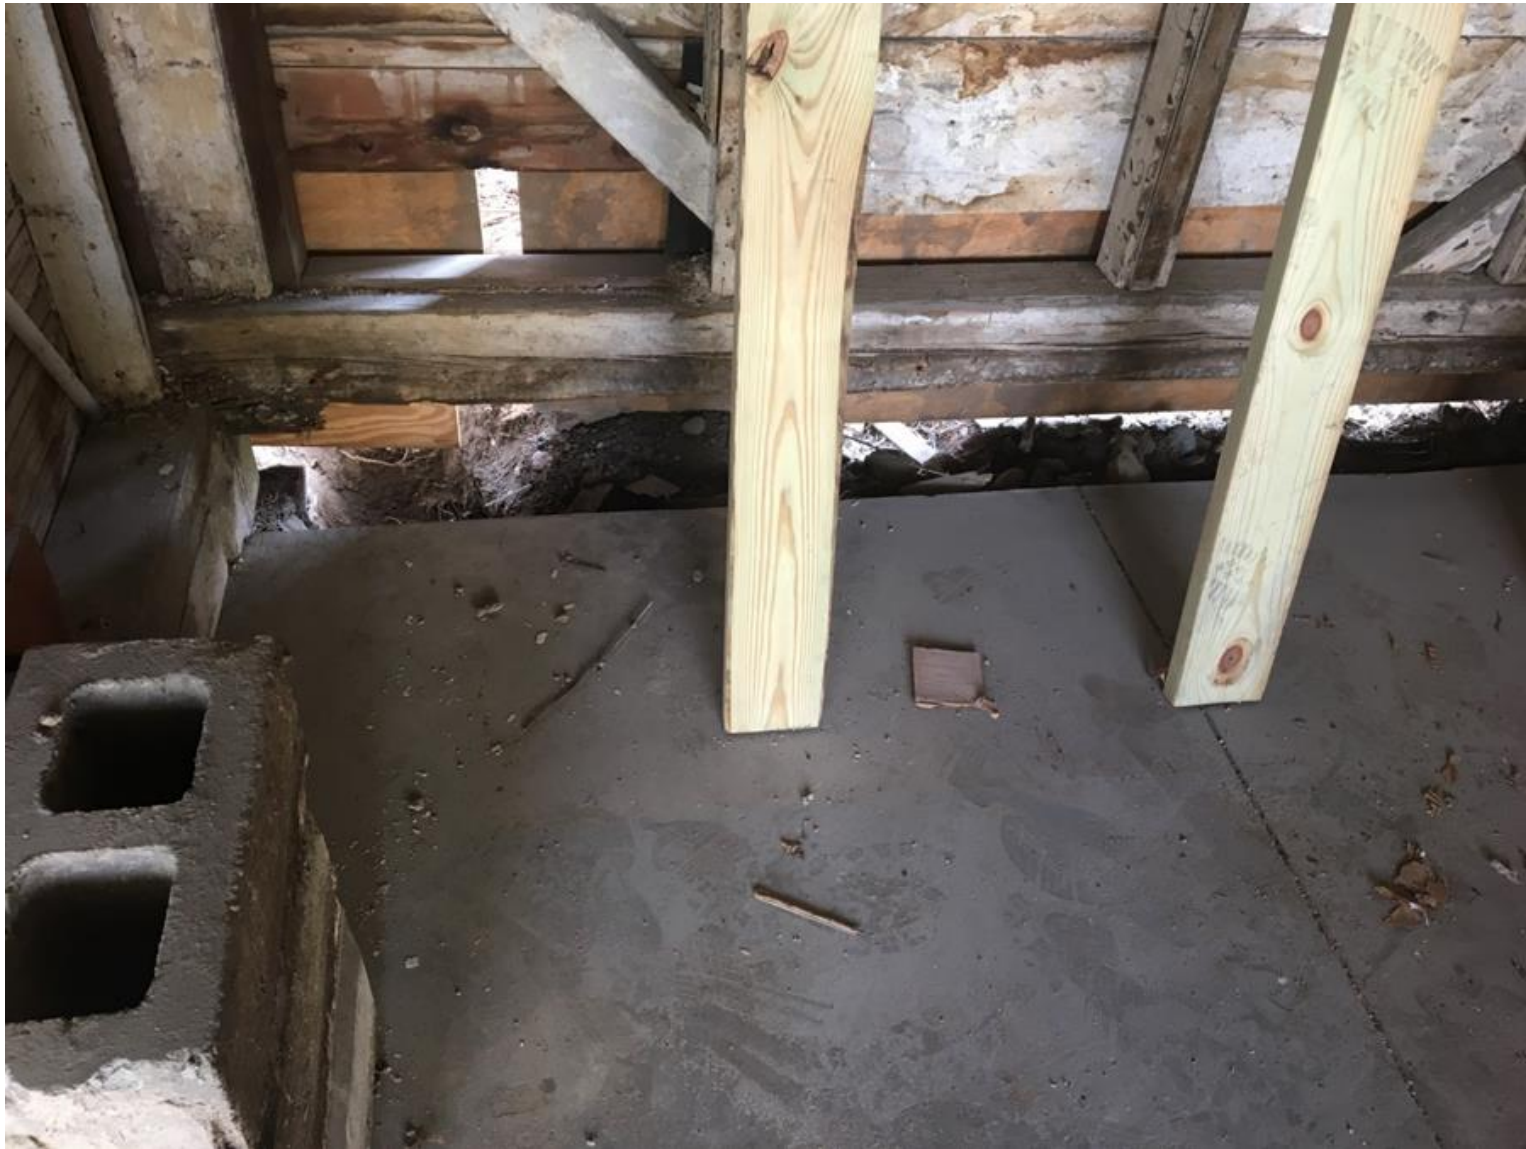
First garage bay, rear wall. Missing CMU course, frost wall. *Source: Jim Feeney*

Much effort was made to remain true to the building's aesthetic and historical character, including details which not be otherwise readily apparent. For example, a missing section of the foundation, necessary for supporting a garage wall, replaced below grade with a concrete frost wall and above grade with concrete masonry blocks in an effort to show deference to the building style. At the front of the building, where replacement of beveled cement blocks was necessary, matching units were reclaimed from inside the garage space. There, a passage had been

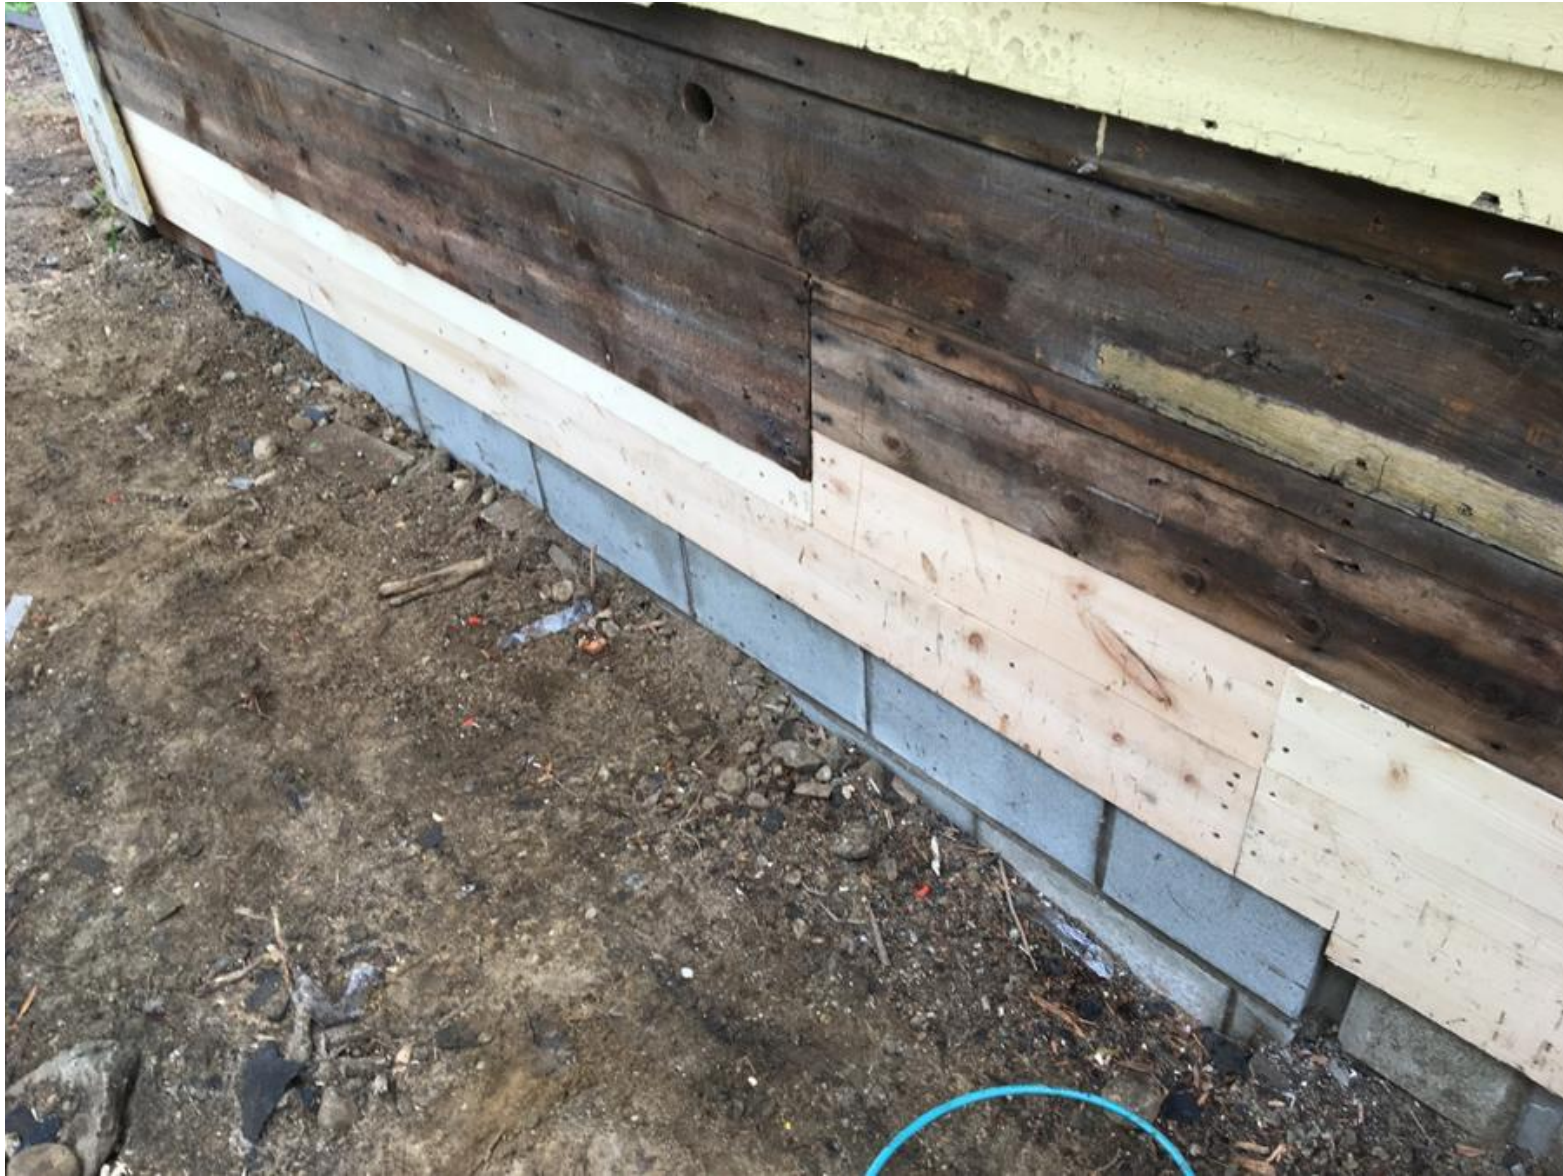
First garage bay, rear wall. New CMU grade beam. *Source: Jim Feeney*

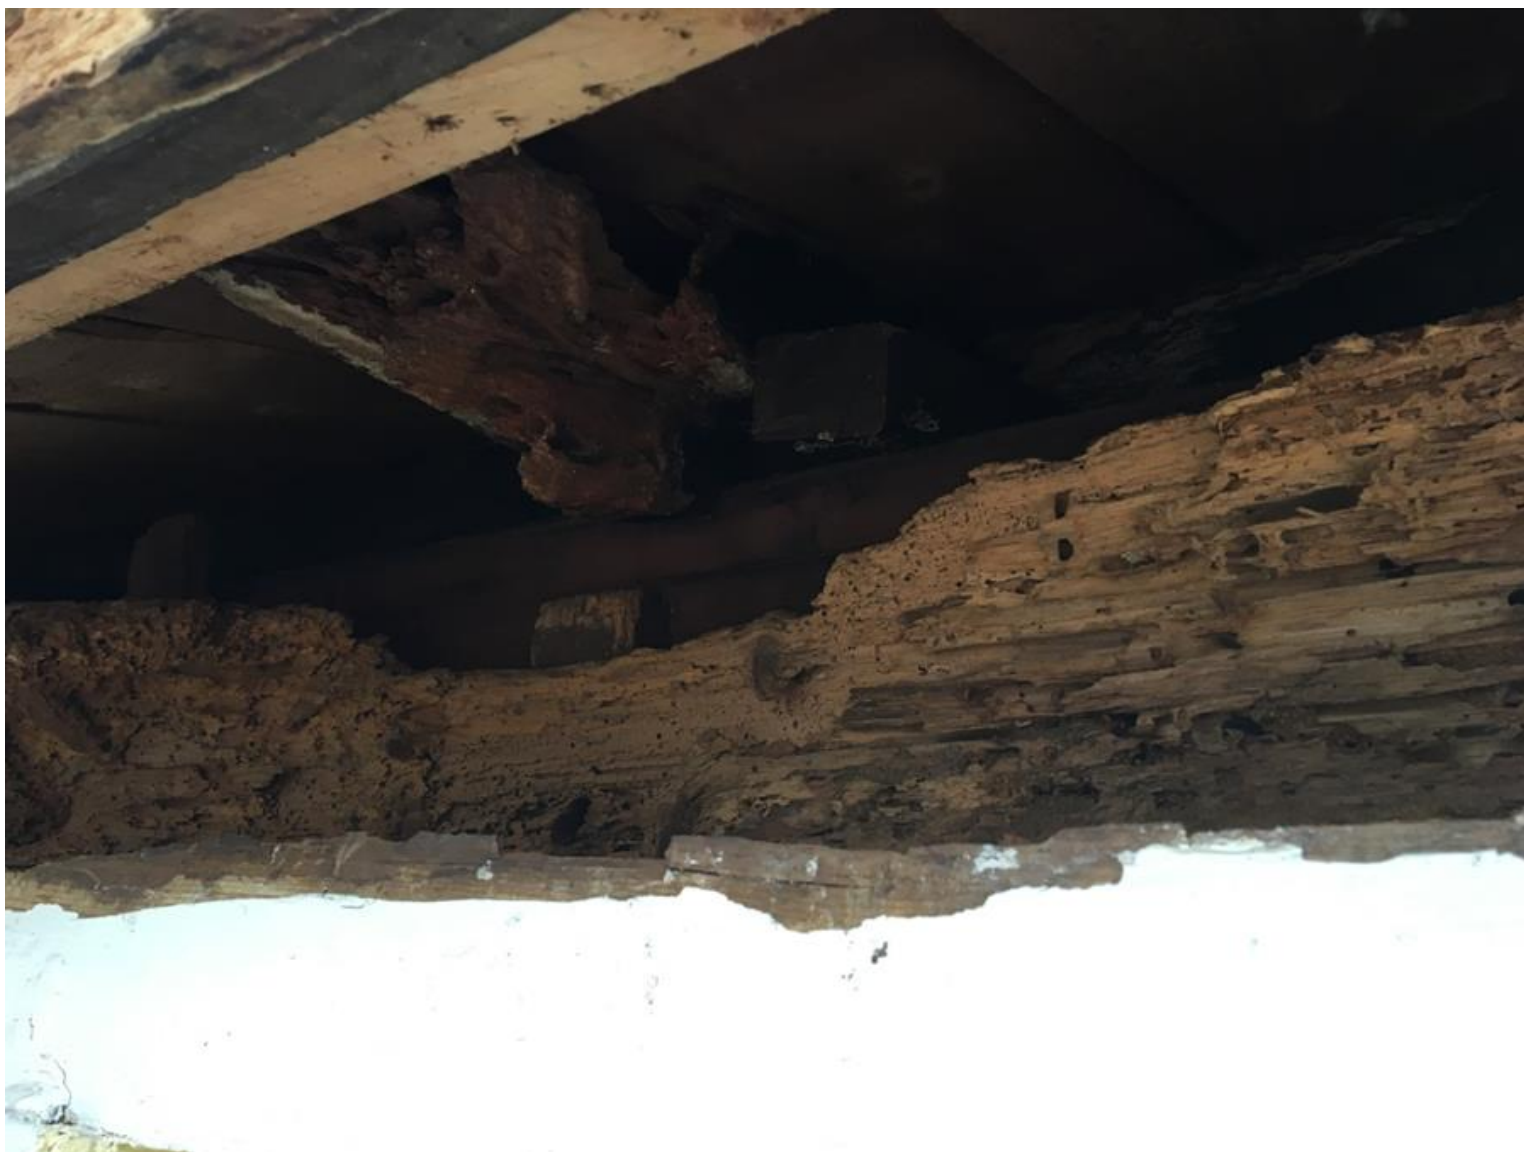
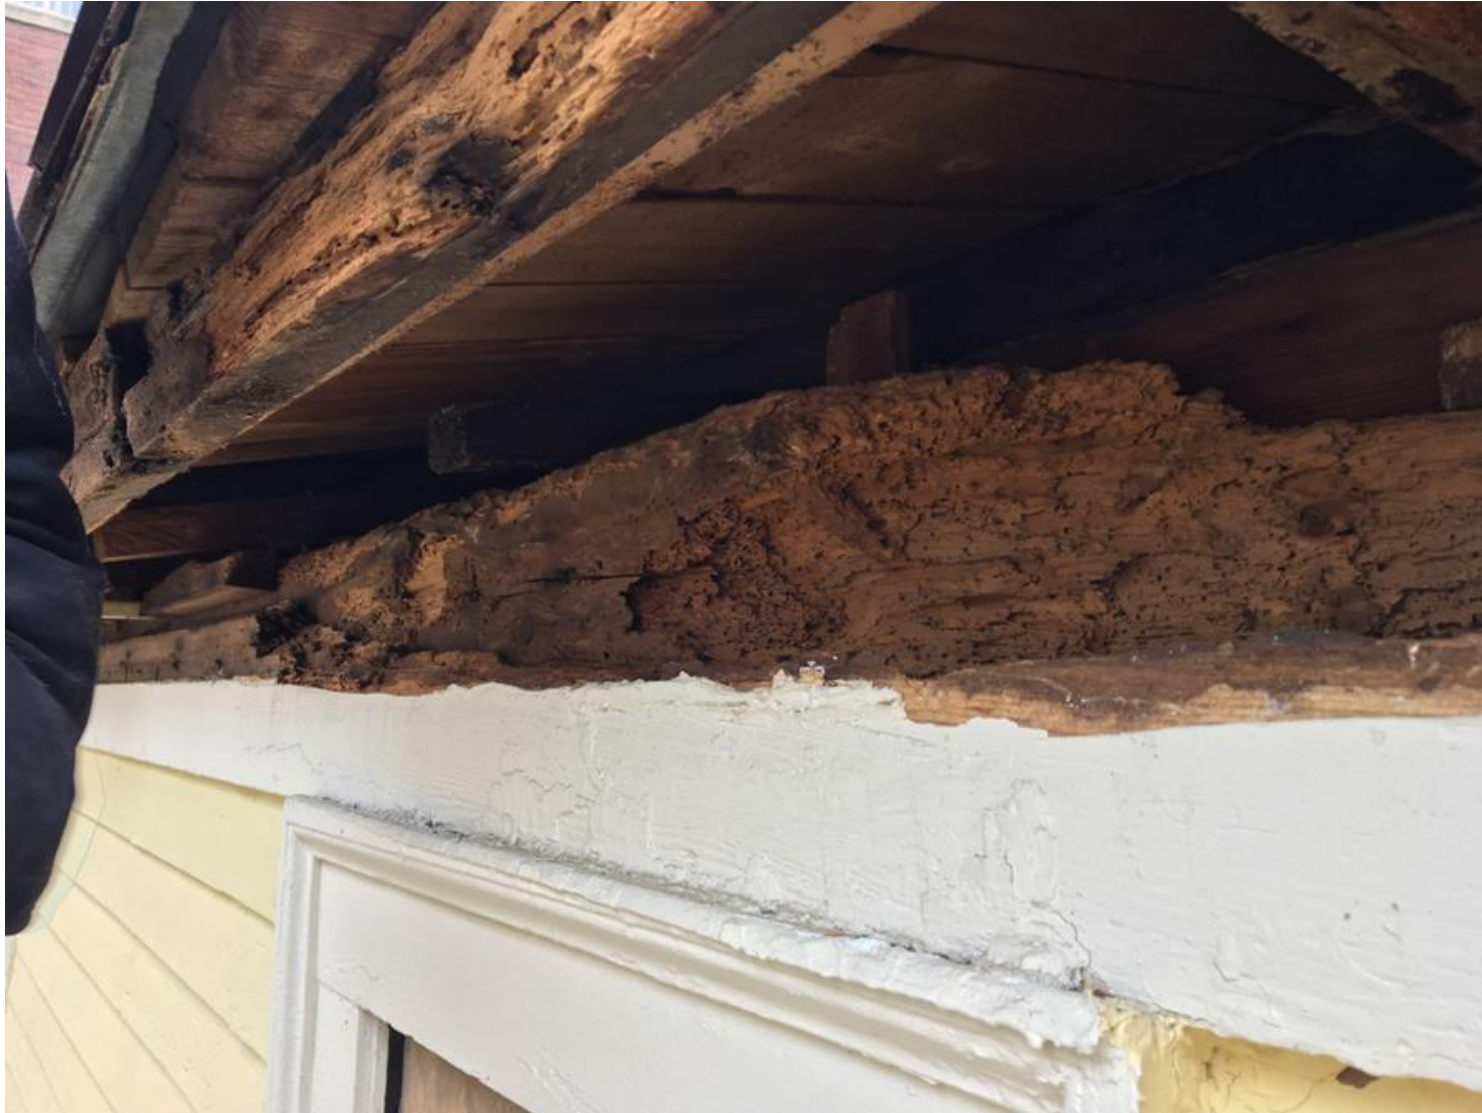
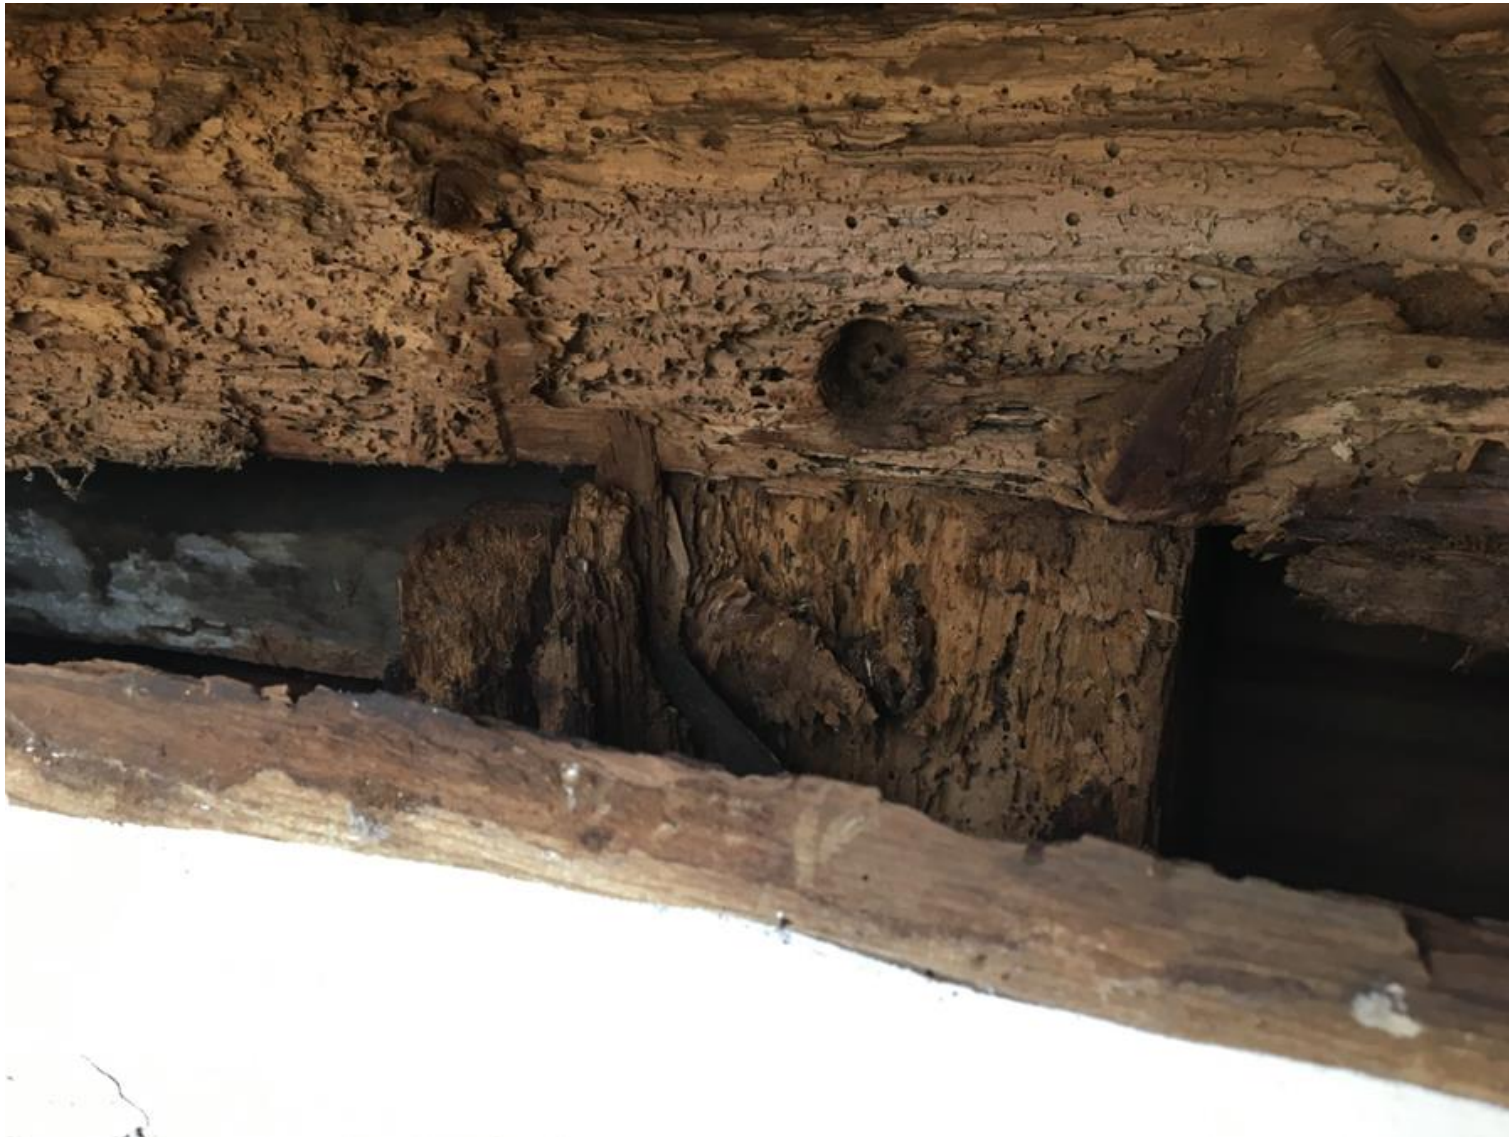
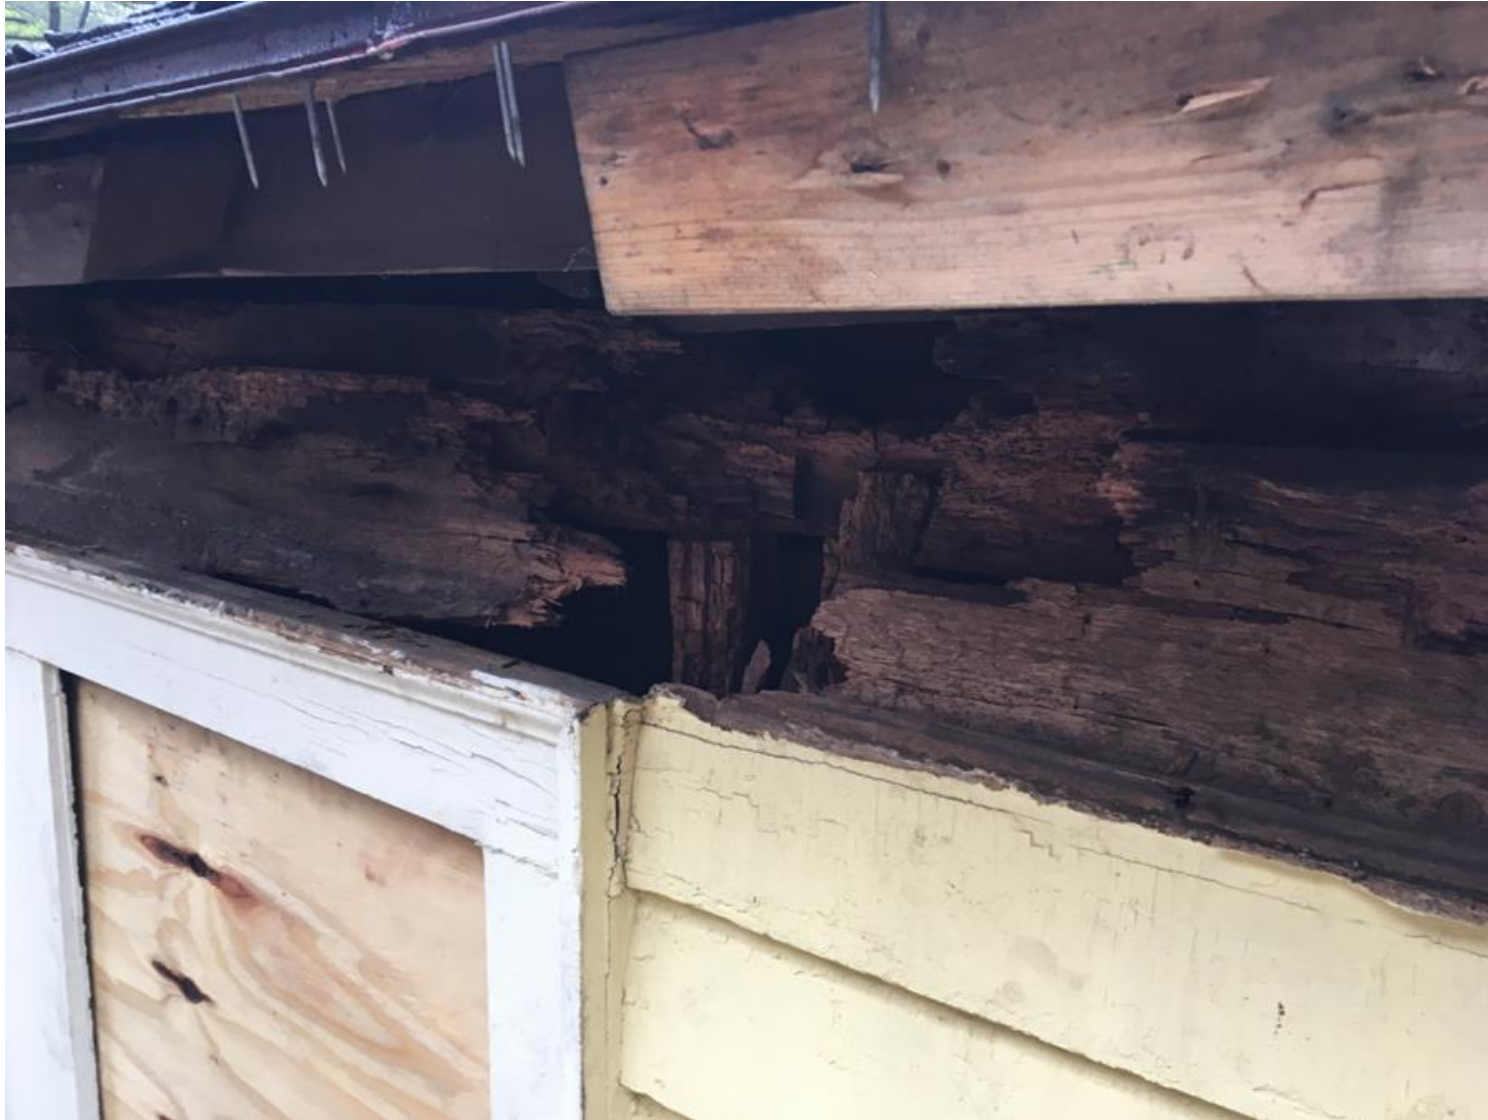
The failures in the wooden gutter roof drainage system also contributed to failures in the structure. As the layers were peeled away, significant structural issues were detected in the framing of the cornice and walls. Over seventy-five percent of the buildings horizontal perimeter beams were rotted and needed to be replaced. Arthur H. MacLeod, P.E., Principal of *MacLeod Consulting, Inc.*, in Belmont was the project engineer and well-versed in the preservation of historic structures. Care was taken to design and implement a plan that would restore the structural integrity of the building without compromising historic building fabric. Photo documentation of these conditions is included in this report.

Main structure. Main perimeter beams at lower roofline, roof purlin had significant water and insect damage. Source: Jim Feeney
